KHYAH VILLAGE SETTLEMENT

Hamirpur, Himachal Pradesh, India

A Design Research Report

by
Batch 2006-2011
B.Arch

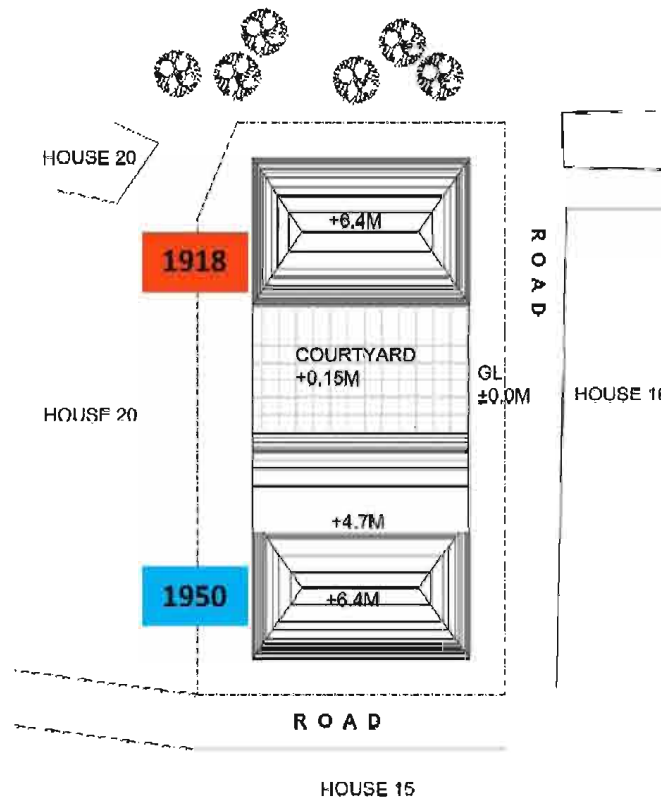
**SITE PLAN**

- The house follows the ancient system of courtyard planning.
- It has a poor drainage system in which drain water flows into the open.
- There is no toilet in the house and neither was it planned initially.
- The house has been build in phases.

- Flooring** : Mud, cow dung, leaves, bamboo.
- Walling** : Sun dried adobe blocks, mud, cow dung Plaster.
- Foundation** : Stone and mud mortar.
- Roofing** : Bamboo, slates.

- Initially the block of the house was built with no staircase access to the top floor in 1918.
- After this the staircase was added.
- Another block was added still further around 1950.
- Staircase of this block was added some years later.

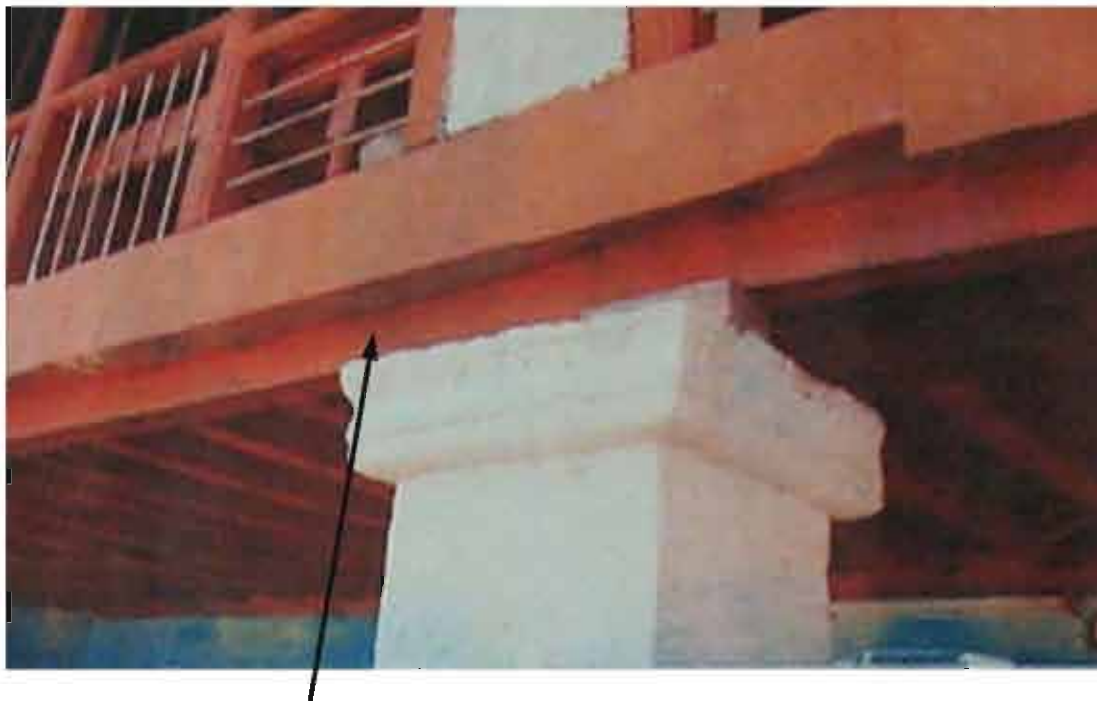
IRON GIRDER RESTING ON THE STONE PILLAR

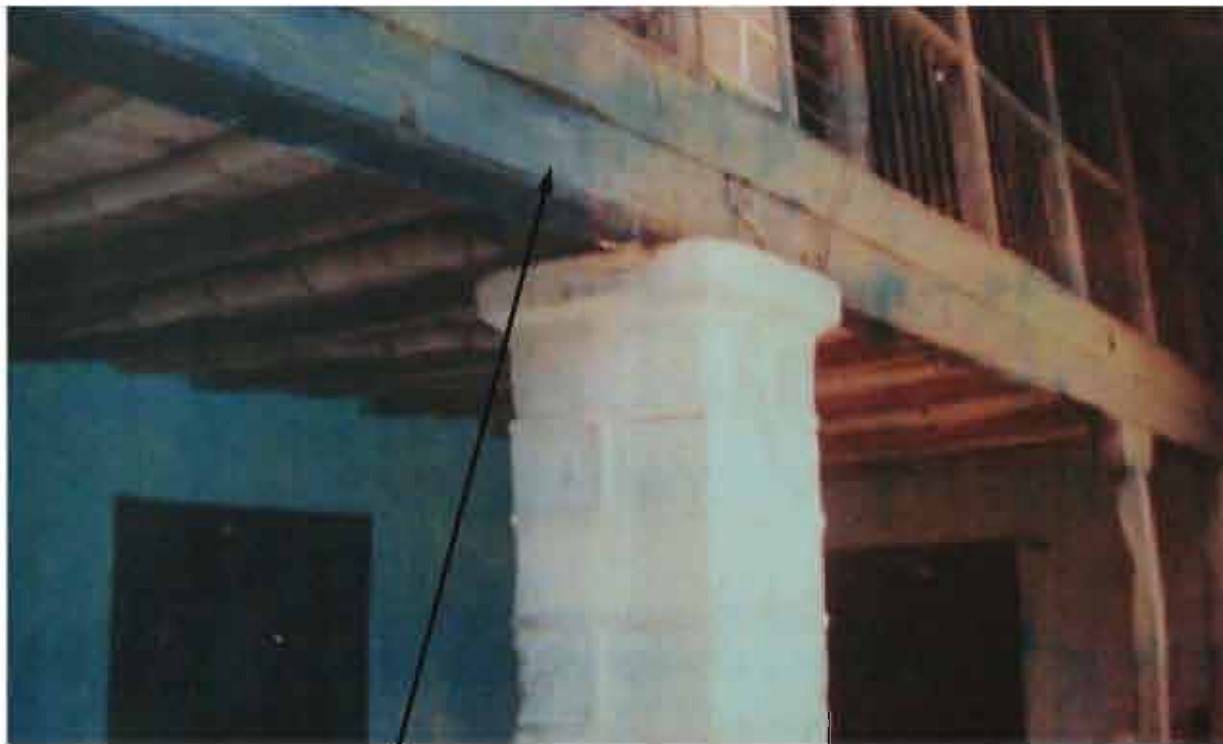
WOODEN BEAM RESTING ON THE STONE PILLAR

- The slab of the first floor is usually 4" that is 162mm thick.
- To support this slab in the front elevation usually girders are provided which may be of iron or wood.
- Where wooden beams are used generally additional wooden supports are provided in between the stone pillars
- First floor slab rests on the wooden/bamboo rafters which are firstly embedded in to the wall
- On these rafters bamboo splits are laid and on these sheets further Khajoor leaves / Jute Bag are kept for mud cow dung mortar (in the ratio 3:1).
- After it is leveled, cow dung paste is applied on top.

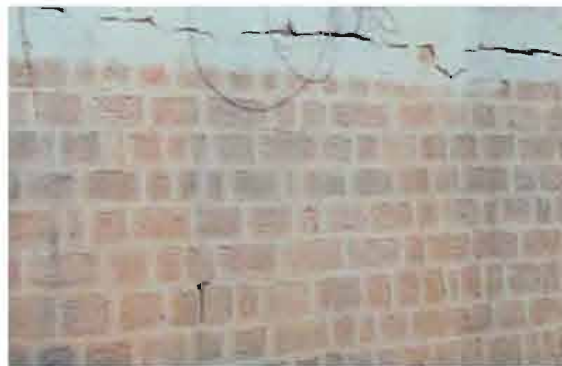
Change in materials causing cracks in the wall

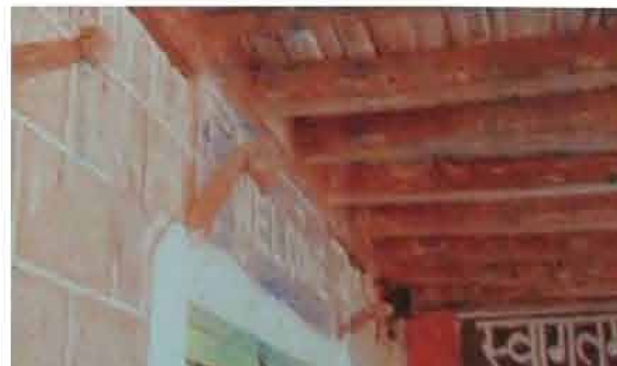
Wooden Hangers Embedded in the wall

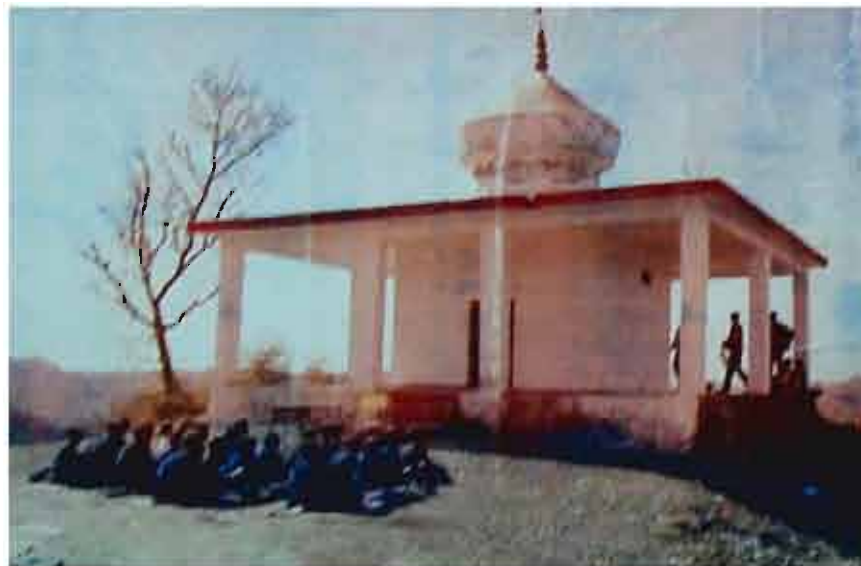
Hilltop Community Temple T2

Single Storey Structure

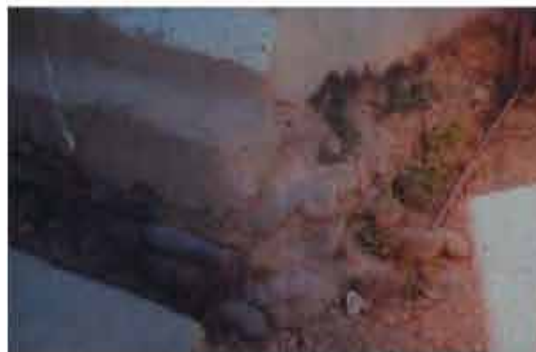
Boulder and Mud Foundation

While laying the foundation of house, the earth is dug up till a hard strata is found below the surface of earth. The digging for search of hard strata can go to the depth of 9 feet or 3m approximately. Hard Strata ranges between 6 feet to 20 feet. If still no hard surface is found, the surface is made hard by use of stones. On this hard surface then the foundation surface is laid using mud brick mortar. The use of stone for the foundation goes till plinth level after which mud walls start.

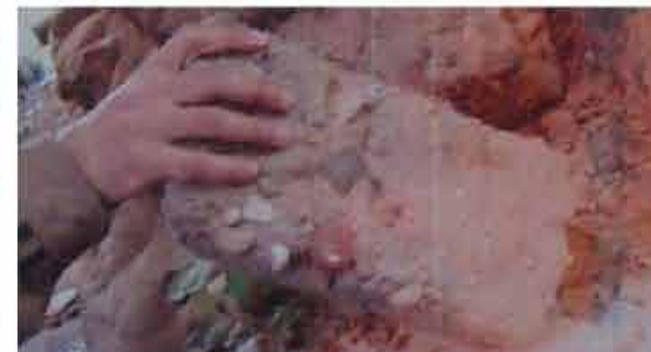
Sun Dried Mud Brick

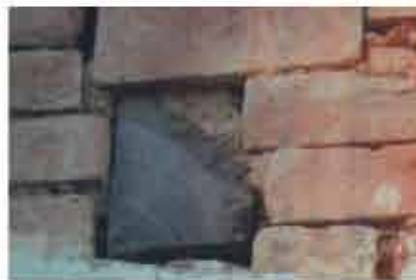
Wall Piece made of 1/4th Tree Trunk

- The roof found in all the houses is made up of slate and bamboo (may be replaced by other kind of wood).
- For laying of roof a grid of bamboo is made the spacing between the members of the grid varies from 300-450 mm.
- The horizontal and vertical members of the grid are nailed together and then the grid is rested upon the walls.
- To this grid the slates are then nailed.

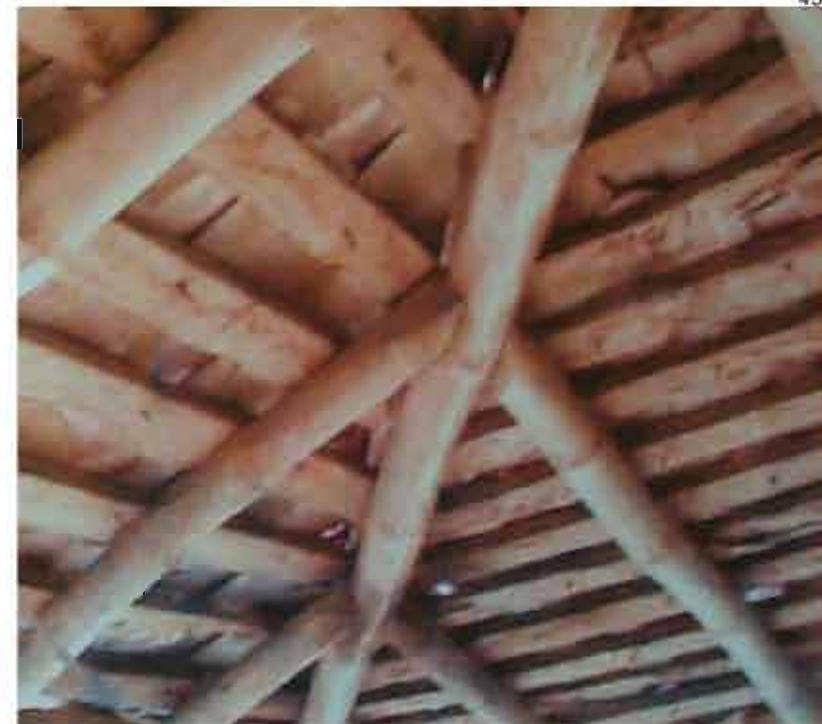
Main Rafter and Common Rafter Joinery on the Roof Hip

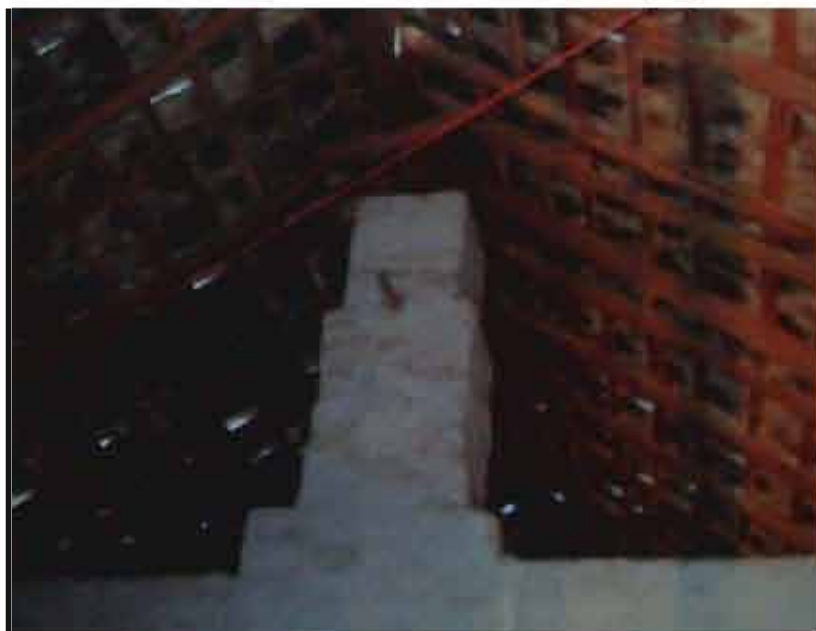
Extra Support for the Ridge on Internal Wall

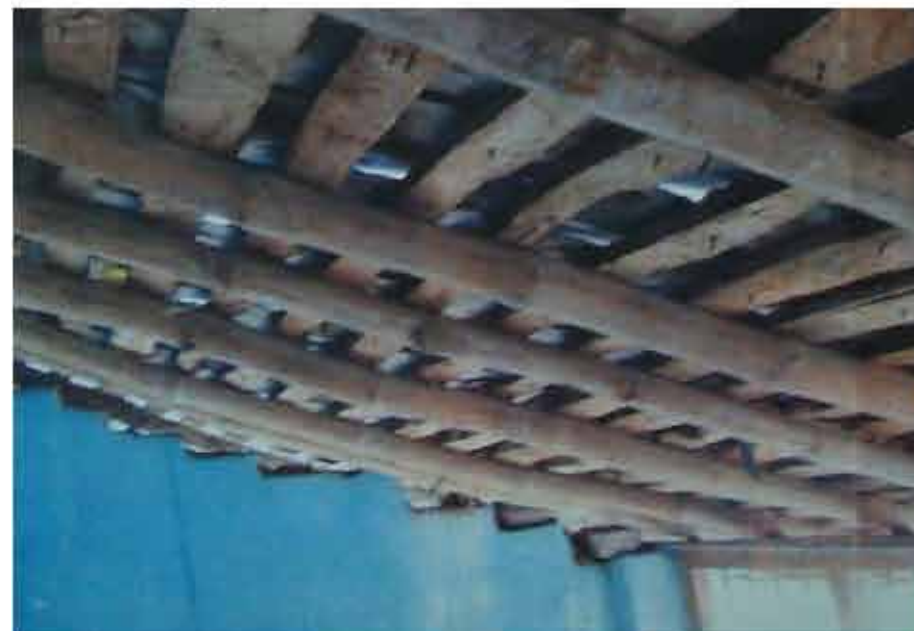
Rafter and Batten Grid Under The Slate Shingles

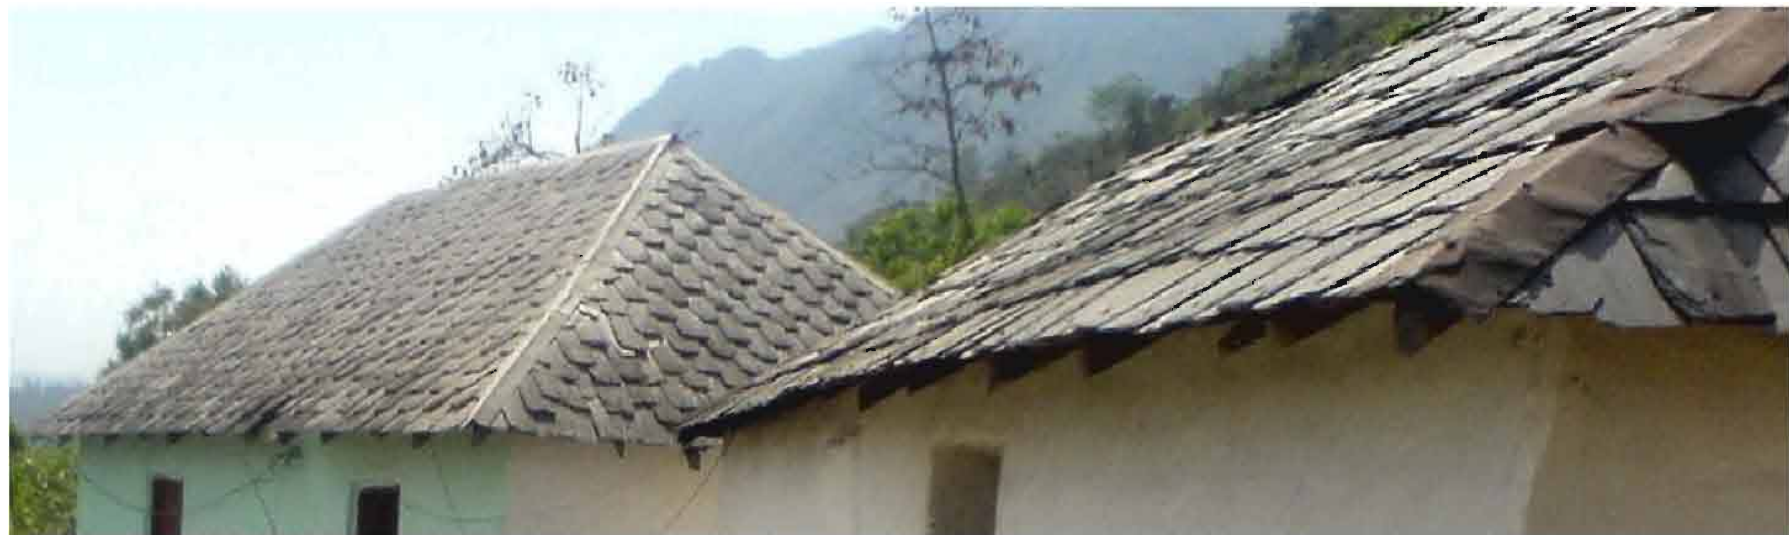
TYPICAL SLATE SHINGLES ARRANGEMENT
